Water Compliance Inspection Report

Name and Location of Facility Inspected (For industrial users discharging to POTW, also include POTW name and NPDES permit number)	Entry Time/Date	Permit Effective Date
R Bajema Farm Inc 792 E Badger Rd Lynden, WA 98264	9:48 am <u>02/12/2013</u>	
	Exit Time/Date	Permit Expiration Date
	10:00 am <u>02/12/2013</u>	
Name(s) of On-Site Representative(s)/Title(s)/Phone and Fax Number(s)	Other Facility Data (e.g., SIC NAICS, and other descriptive information)	
Roger Bajema, Owner, (b) (6)	Unpermitted	
	Denied Access	
Name, Address of Responsible Official/Title/Phone and Fax Number	NAICS: 11212 <u>8</u>	
Roger Bajema 792 E Badger Rd Lynden, WA 98264	Contacted <input checked="" type="checkbox"/> Yes <input type="checkbox"/> No

Lynden, WA

**Prepared by:
Sandra Brozusky
Environmental Protection Agency, Region 10
Office of Compliance and Enforcement
Inspection and Enforcement Management Unit**

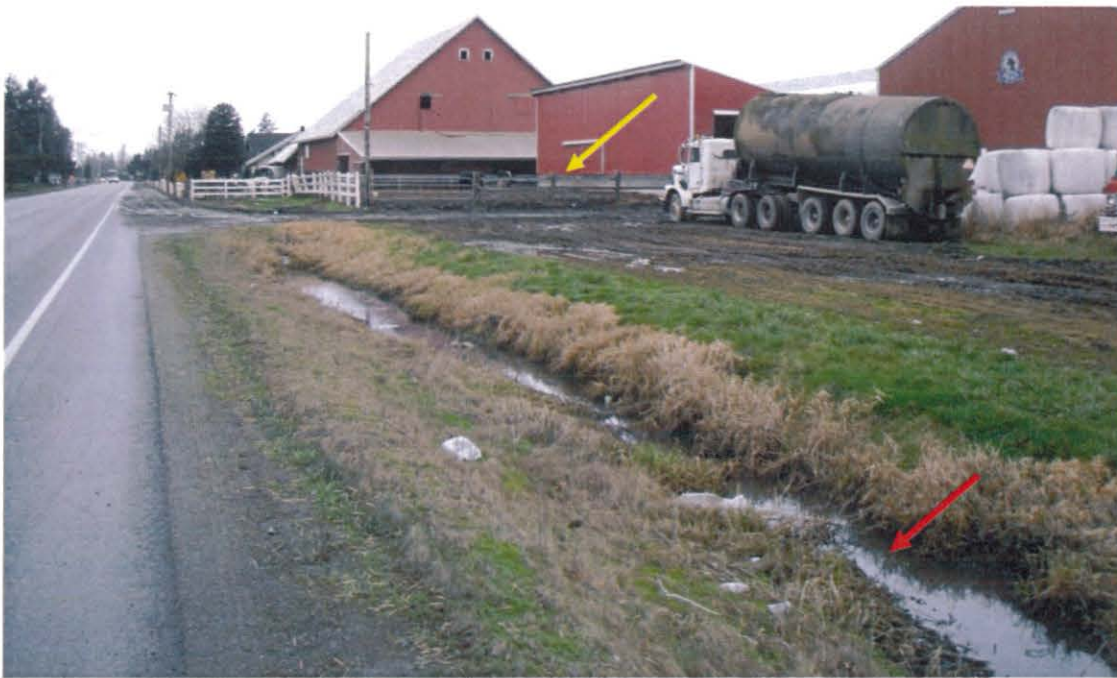
Photograph #1: View of the southern end of the facility and ditch from E. Badger Road. The yellow arrow points to the dry cow confinement area. The red arrow points to the location of sample # 13064100. This photograph was taken by Michael Isensee, Washington Department of Agriculture on February 12, 2013.

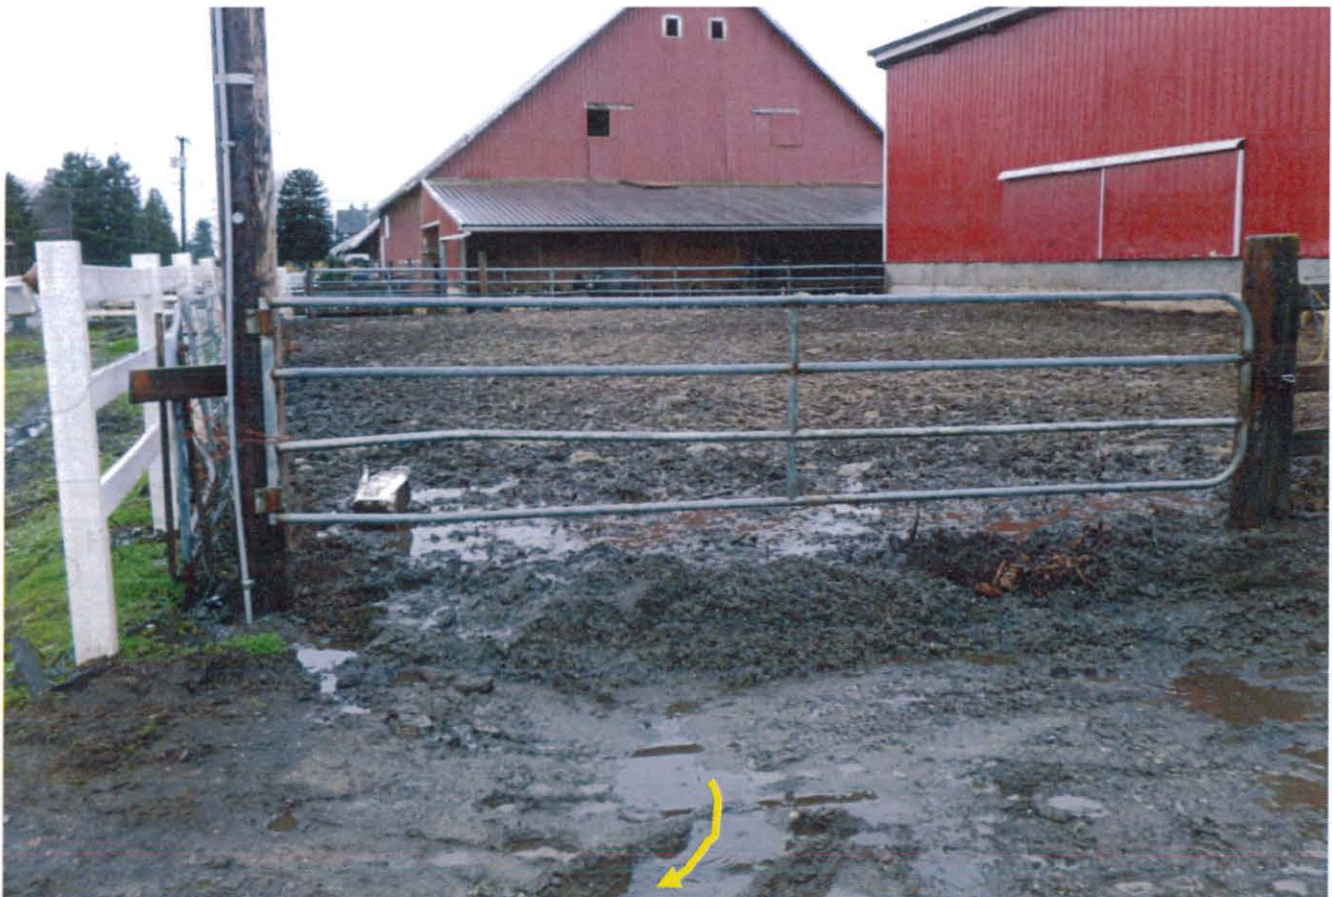
Photograph #2(P1010090-taken on 2/21/13): Looking west, this is a closer view of the dry cow confinement area. On February 21, 2013 the EPA inspectors collected a water sample of flow coming from the direction of the eastern perimeter of the dry cow confinement area. The yellow arrow indicates the direction of flow at this time. In general, the slope along the eastern perimeter of the dry cow confinement area was toward the road and trench.

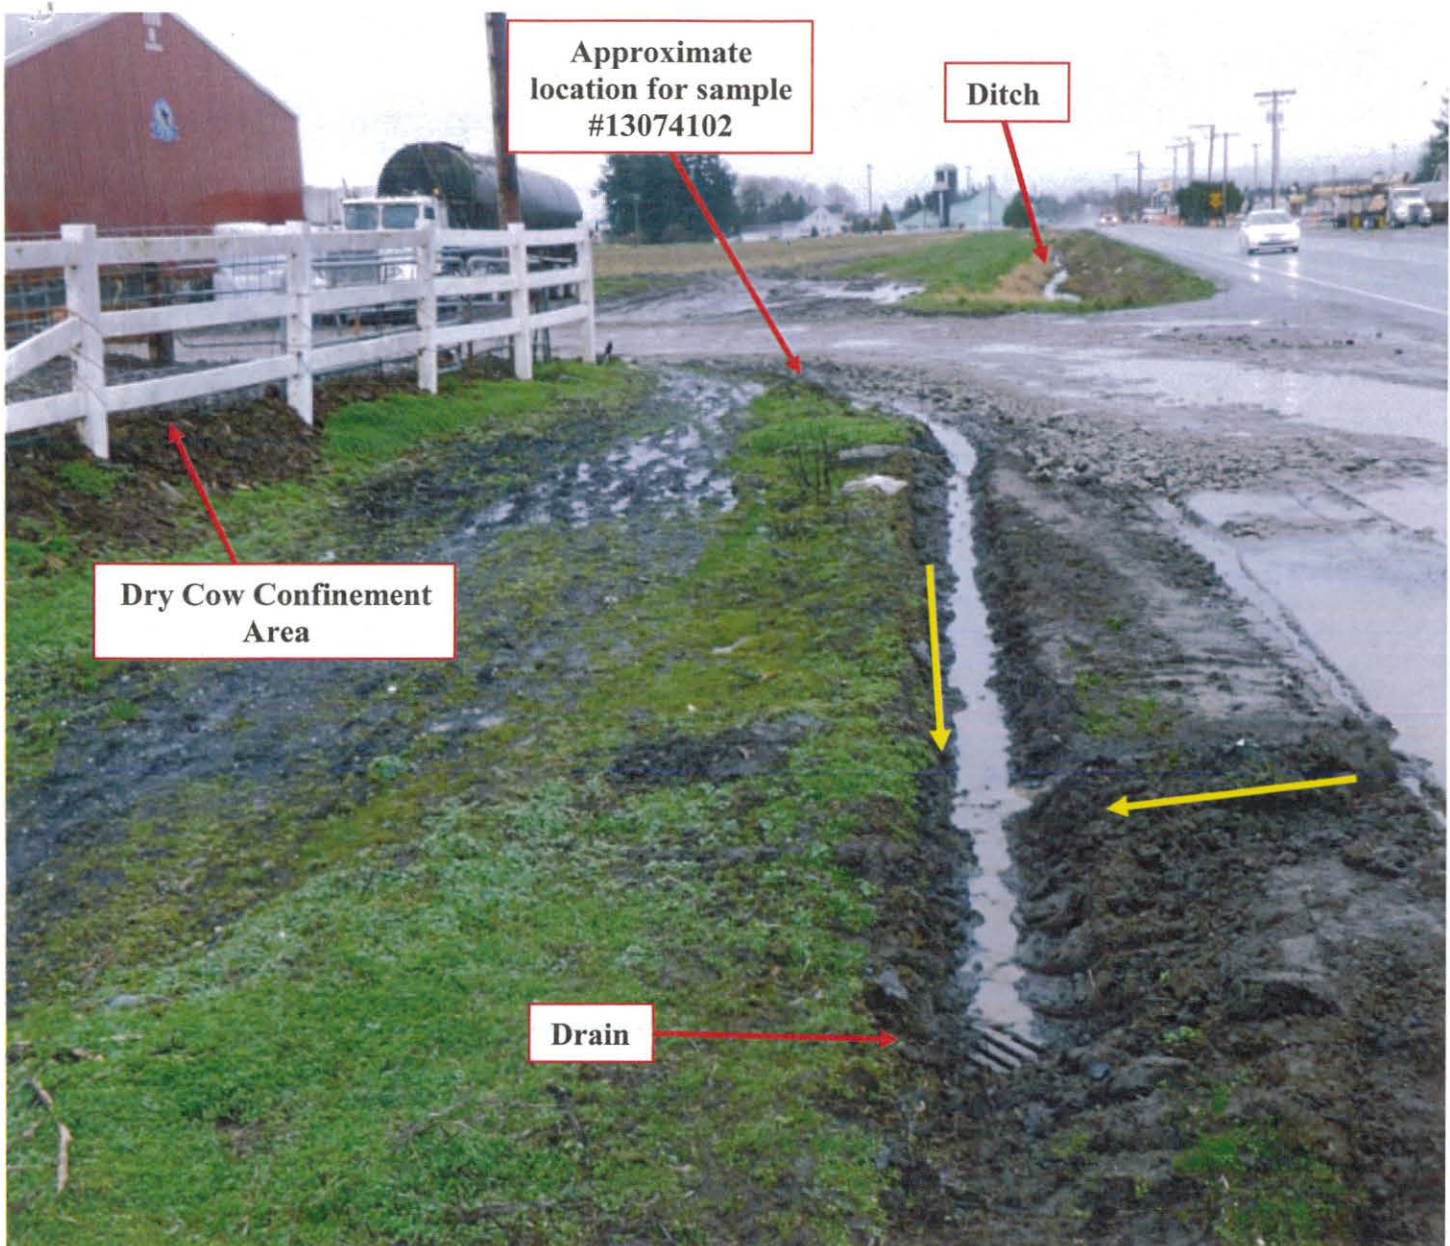
Photograph #3(P1010094-taken on 2/21/13): Looking east, this is a view of the trench located adjacent to the dry cow confinement area and the drain. Water flowing from the direction of the eastern perimeter of the dry cow confinement area was entering this trench and flowed into the drain seen here on February 21, 2013. According to Mr. Bajema, this drain routes water to the ditch, seen in the background of this photograph. The yellow arrows indicate the direction of flow in the trench.

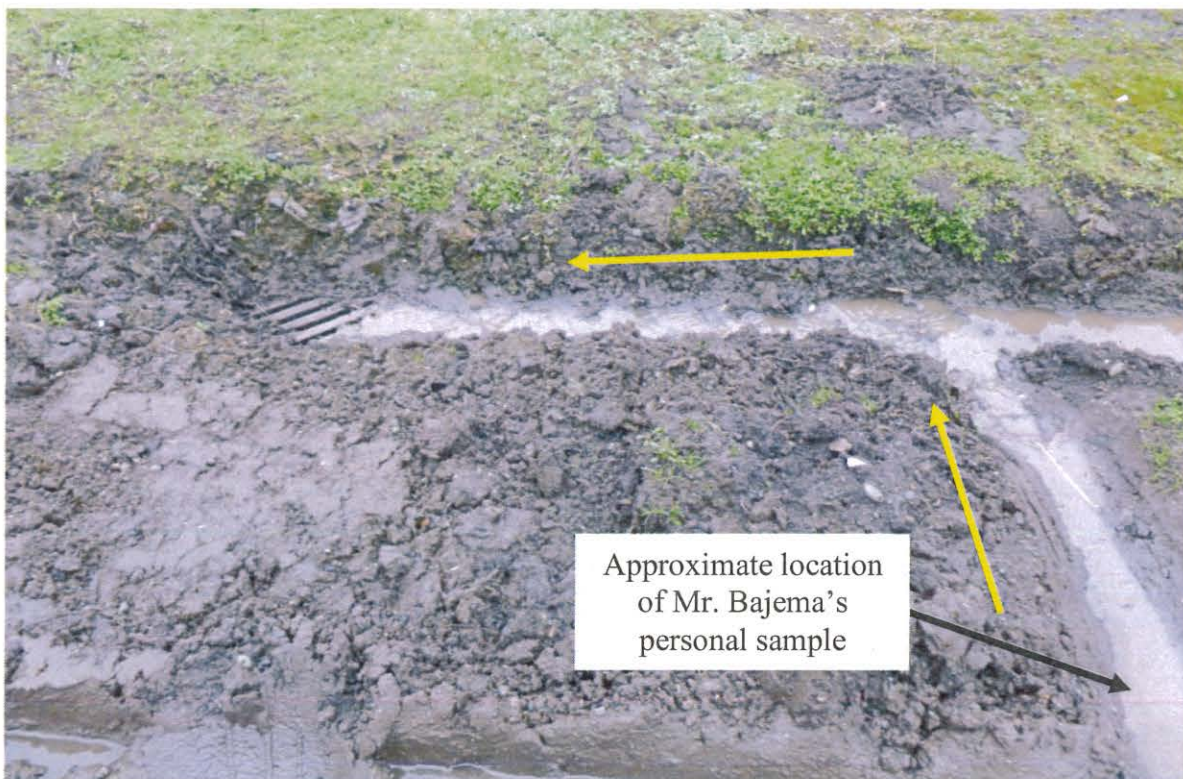
Photograph #4(P1010094-taken on 2/21/13): Another view of the drain seen in the previous picture. Runoff from the direction of the road was also entering this drain, via the channel seen in the bottom right corner of the image. Mr. Bajema collected his personal sample of the water flowing in this channel. The yellow arrows indicate the direction of flow at the time of inspection.

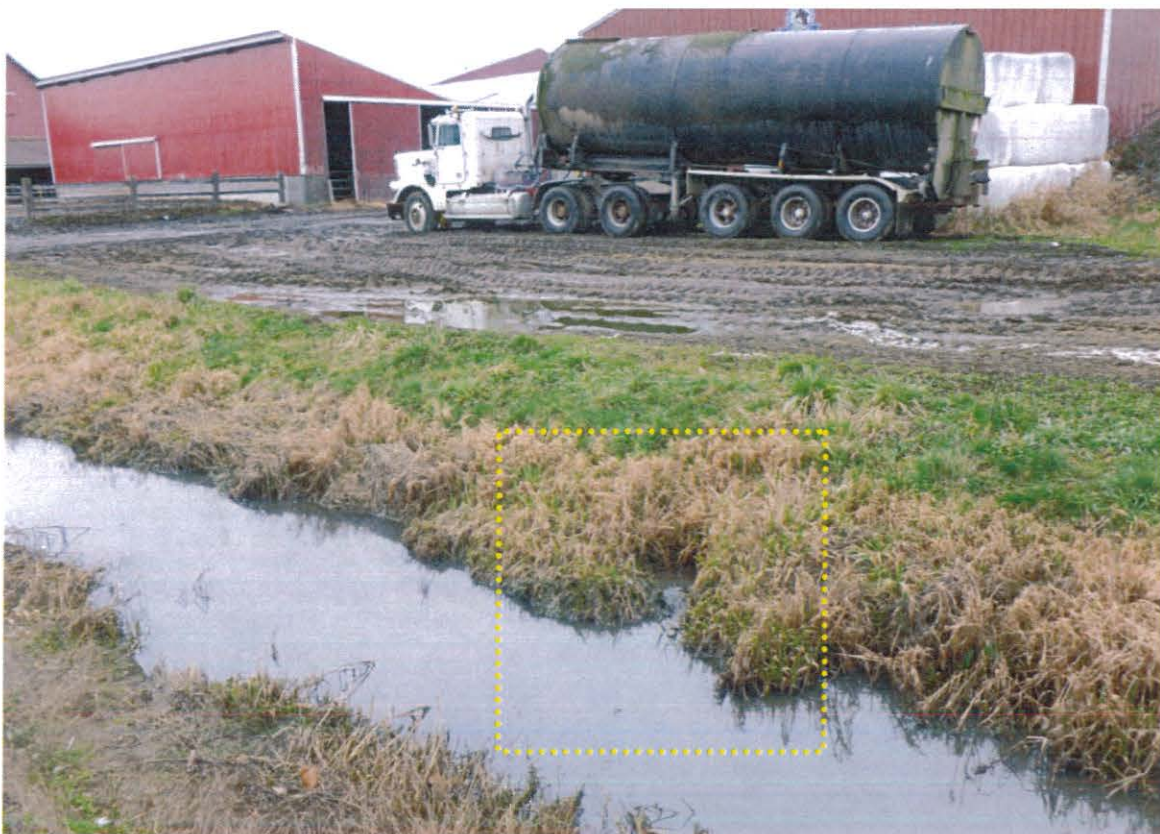
Photograph #5(P1010066-taken on 2/12/13): Looking northwest, this view is of the ditch and the flow of water entering the side of the ditch, highlighted by the yellow box. Mr. Bajema stated that this flow of water is from the northern barn roof runoff. This flow of water is the location for sample #13064101 and # 13074100.

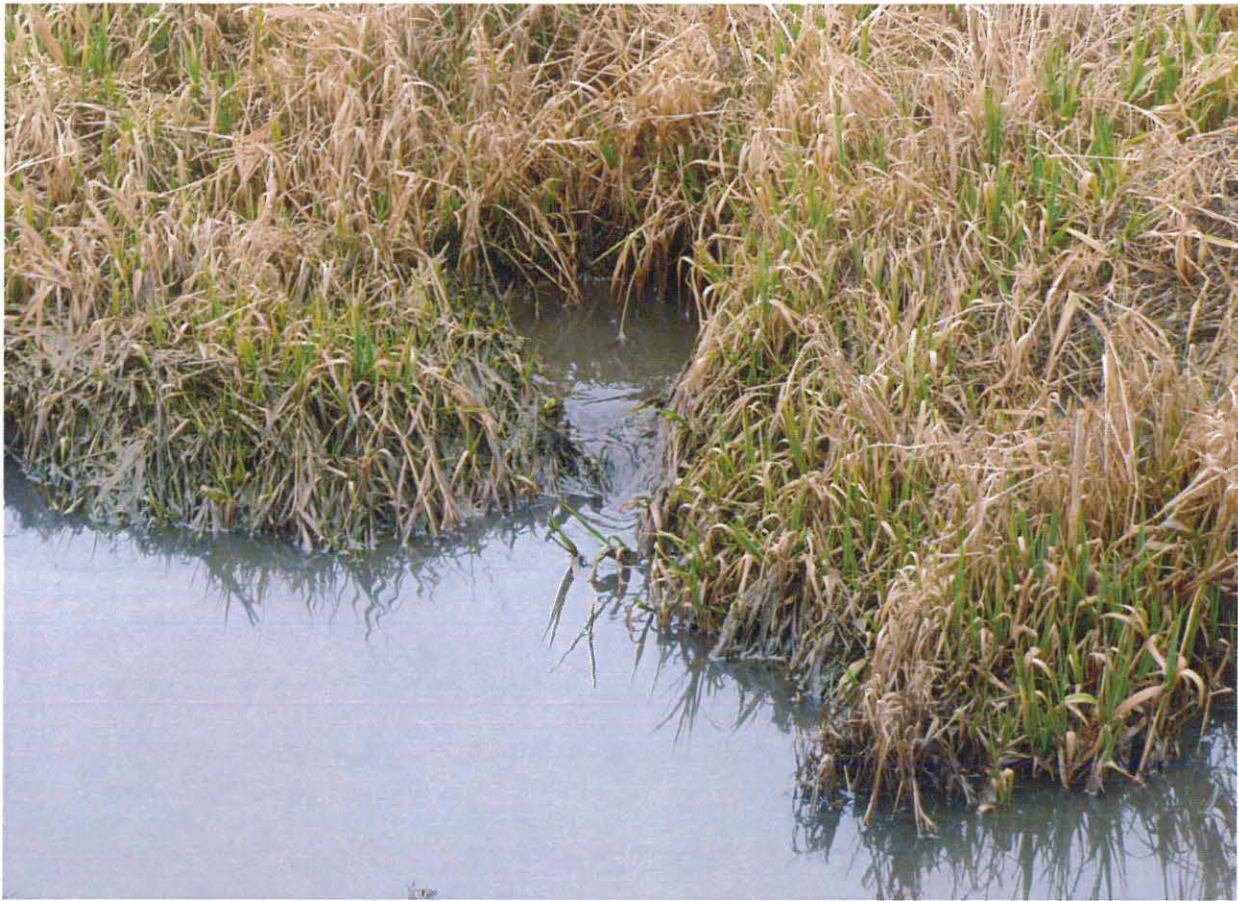
Photograph #6(P1010065-taken on 2/12/13): This is a close up of the water flow seen in the previous picture.

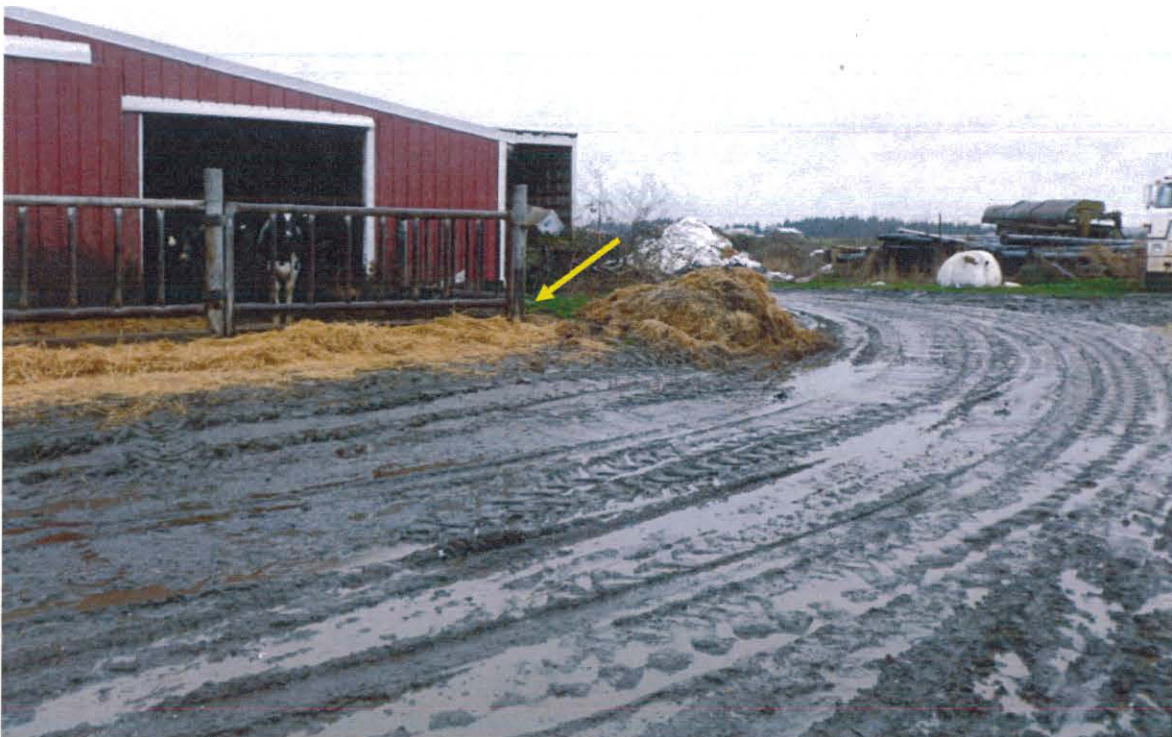
Bajema then described a potential reason for the high results. Roof runoff from the confinement barn on the northern side of the facility drains into a cement trough. Water in this trough is routed to a drain hole, through underground piping and into the ditch. This piping travels east toward an application field and then south until it reached the ditch. Mr. Bajema stated that this pipe, at the location of the application field, was at a shallow depth in the ground, and had been broken. He presumed it was broken by the corn chopper when processing the corn in this field. Mr. Bajema continued to state that this broken pipe was potentially draining water collecting in a portion of the field that also contained applied manure. Water and applied manure that enter this broken pipe would then drain into the ditch.

Photograph #7(P1010086-taken on 2/21/13): Looking at the northeast corner of facility, specifically the northern barn. The yellow arrow points to the location of the roof runoff drain.

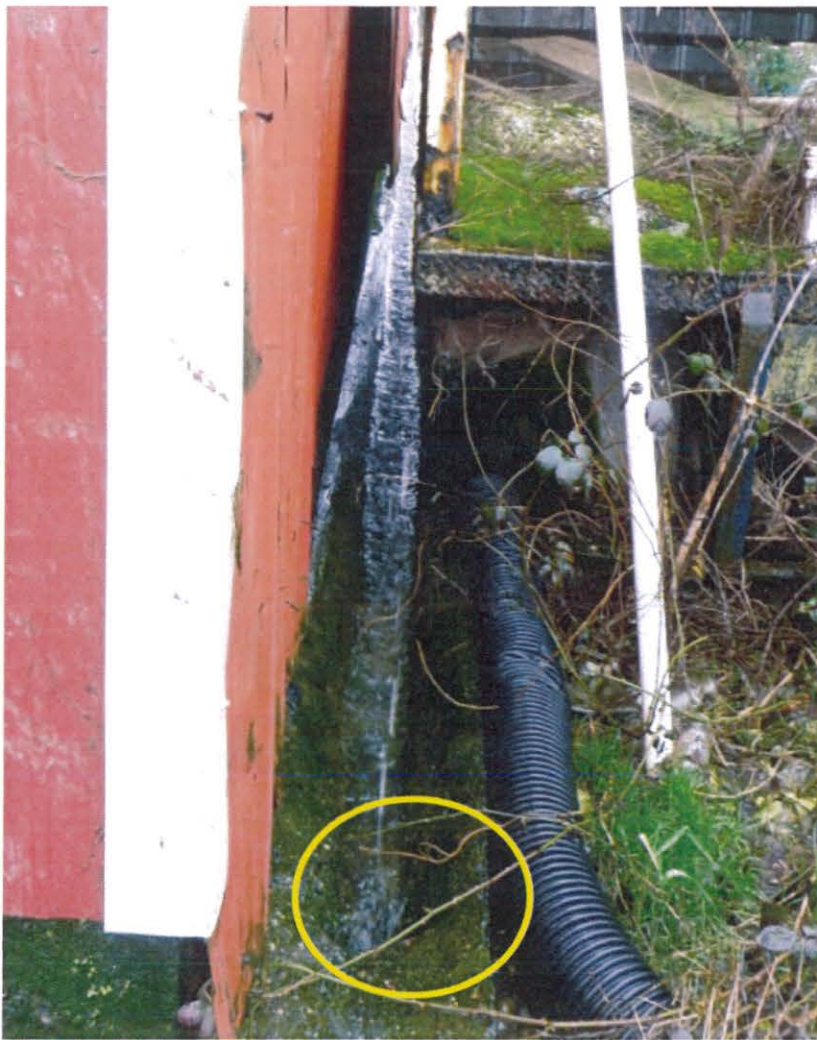
Photograph #8(P1010081-taken on 2/21/13): View of the cement trough that captures and routes roof runoff into the drain (indicated by the yellow circle) and ultimately into the ditch.

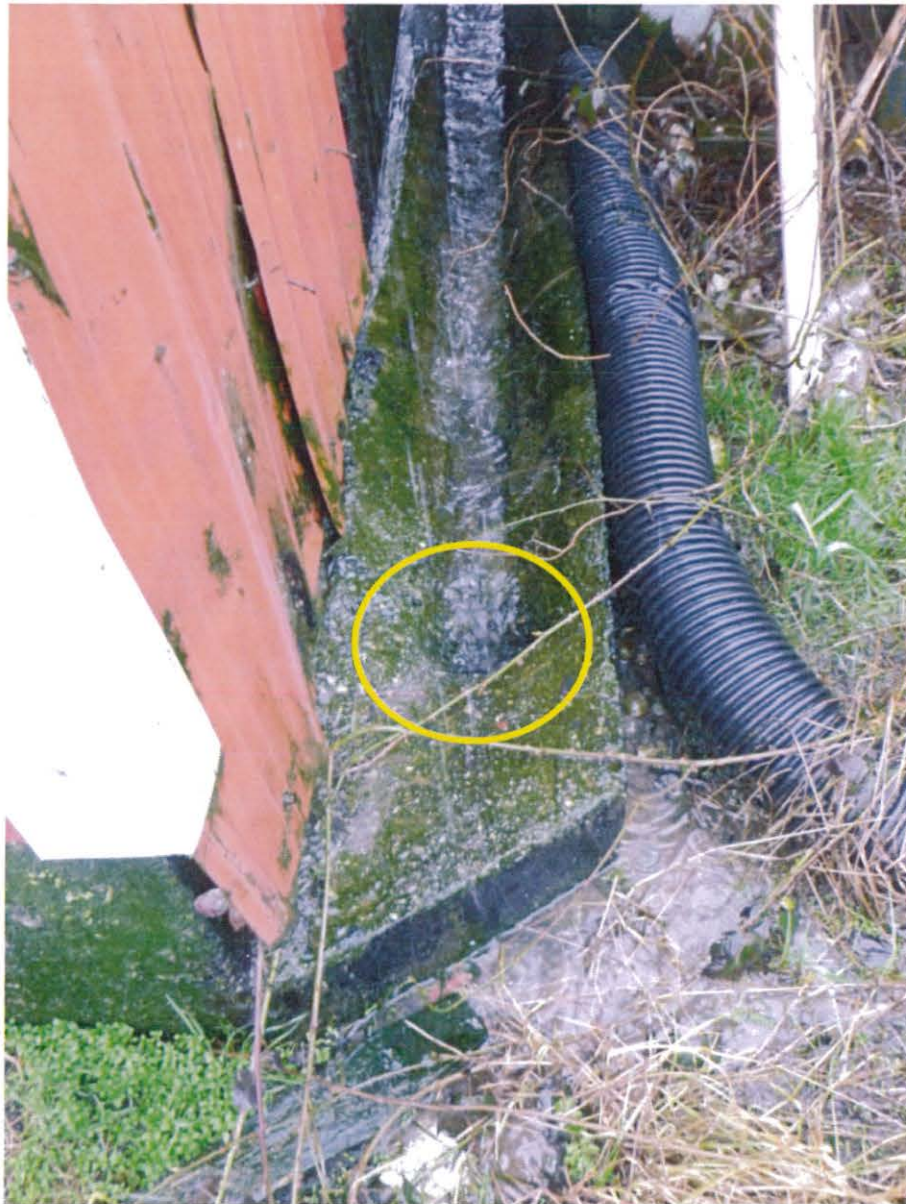
Photograph #9(P1010082-taken on 2/21/13): Close up view of the drain (indicated by the yellow circle) that routes roof runoff into the ditch. Note the cement trough and drain are elevated above ground level.

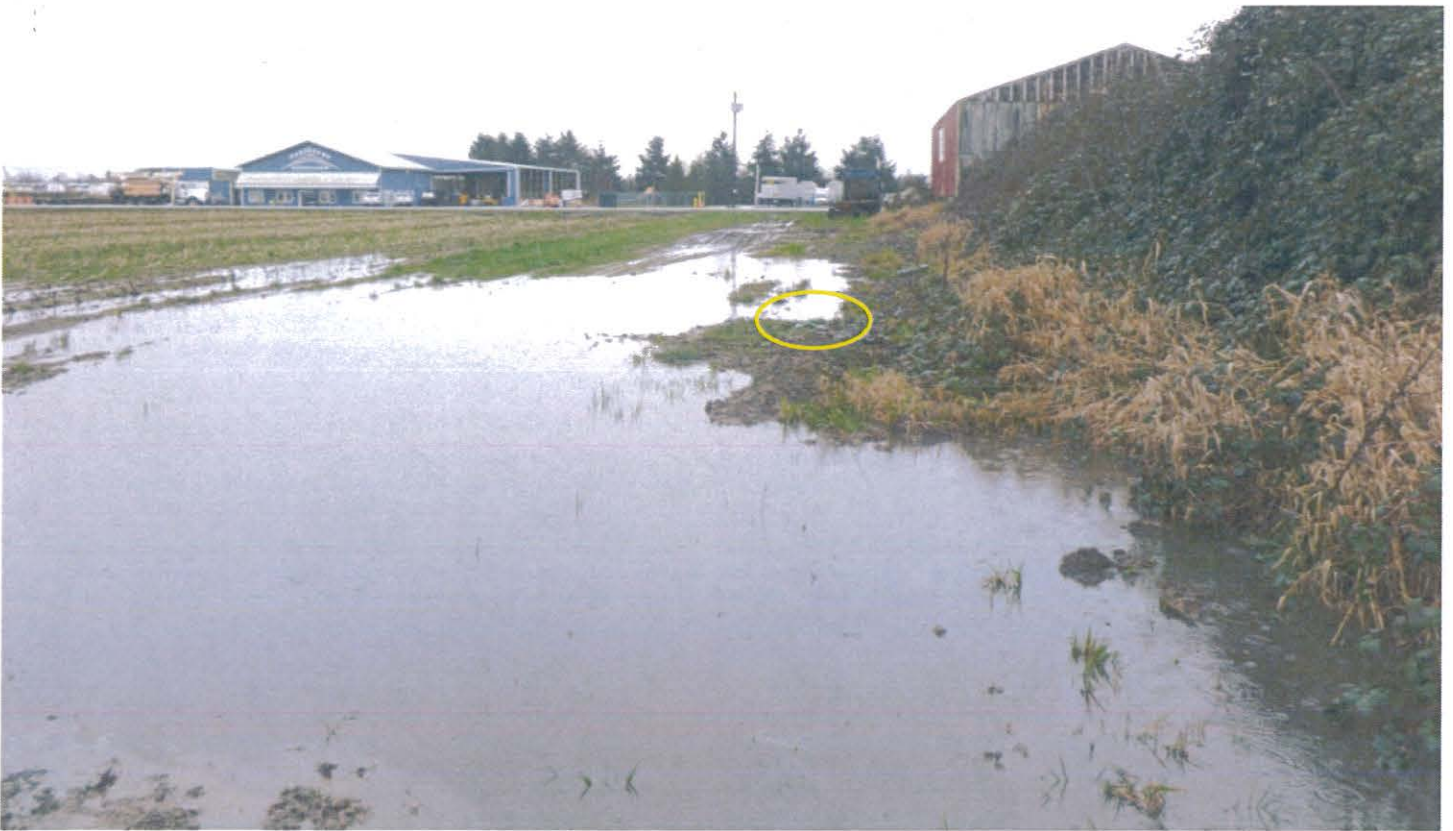
Photograph #10(P1010095-taken on 2/21/13): Looking south, this is a view of the field where, according to Mr. Bajema the pipe routing roof runoff to the ditch was broken. On February 21, 2013 there were pieces of broken pipe in this vicinity. The yellow circle highlights some of those pieces. Mr. Bajema stated that manure that had been applied to this field may have mixed with water and drained into the ditch. The ditch runs parallel to the road seen in the background of the photo.

Mr. Bajema stated he paid for a service to pump the water out of the ditch approximately 9 days prior to our February 21, 2013 inspection. He stated that he had this water pumped as a result of EPA's initial presence on February 12, 2013 and following his discovery that the pipe has been broken. He was unsure as to the length of time the pipe had been broken. Mr. Bajema stated that he used his employees to repair the pipe.

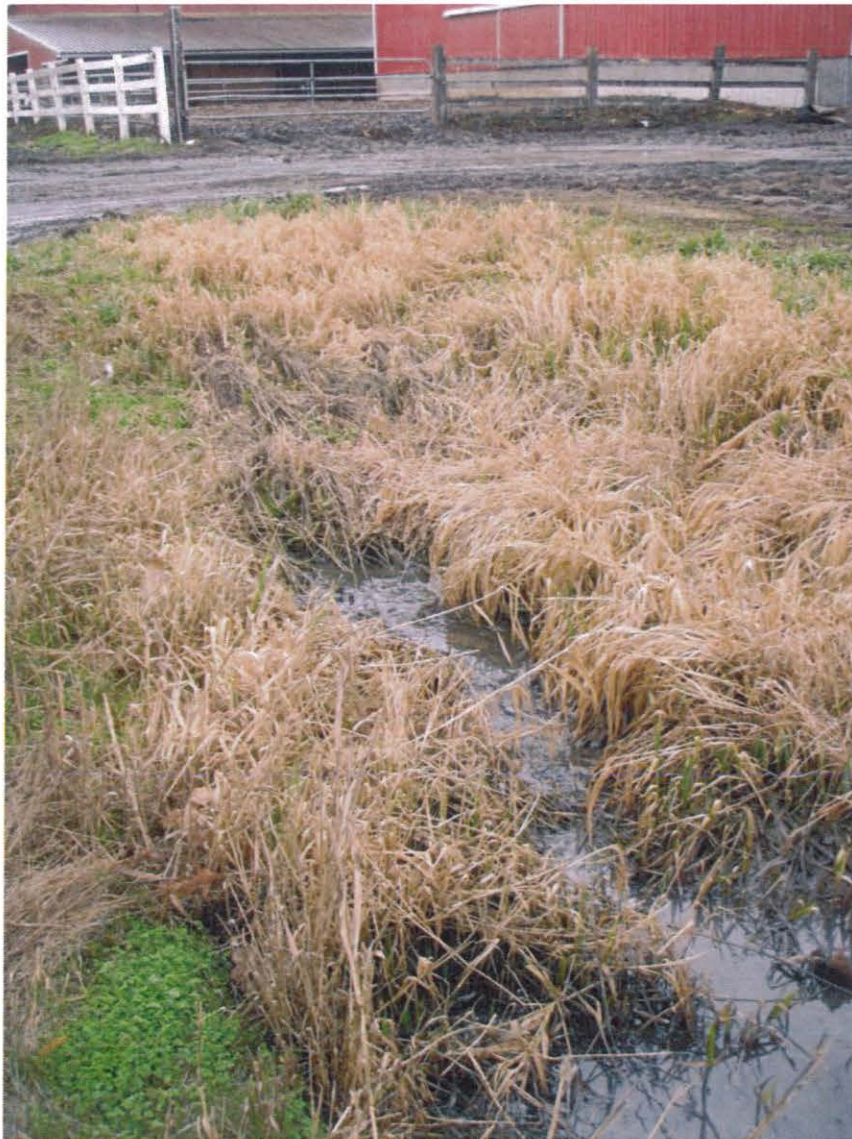
Photograph #11: View of water flowing at the beginning of the ditch. This is the sample location for #13064102 and #13074101. This photograph was taken by Michael Isensee, Washington Department of Agriculture on February 12, 2013.

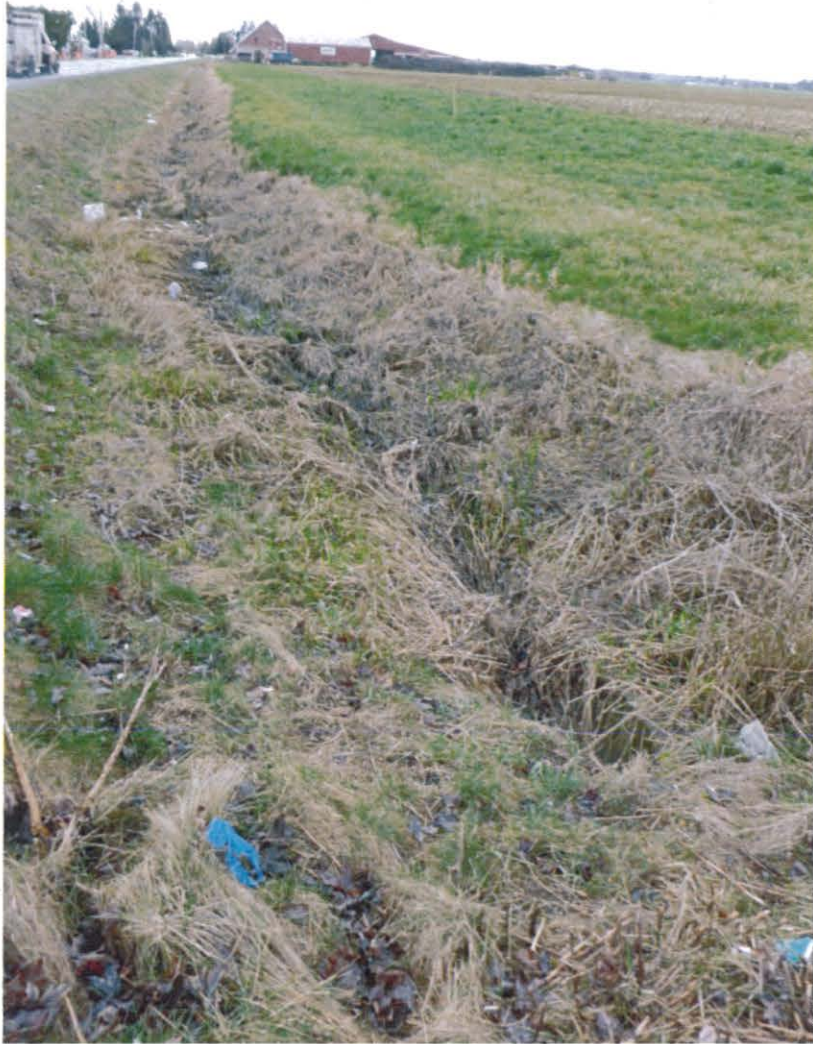
Photograph #12(P1010101-taken on 2/21/13): Standing at the intersection of Bender Road and E. Badger Road, this is a view of the ditch, looking west back at the facility.

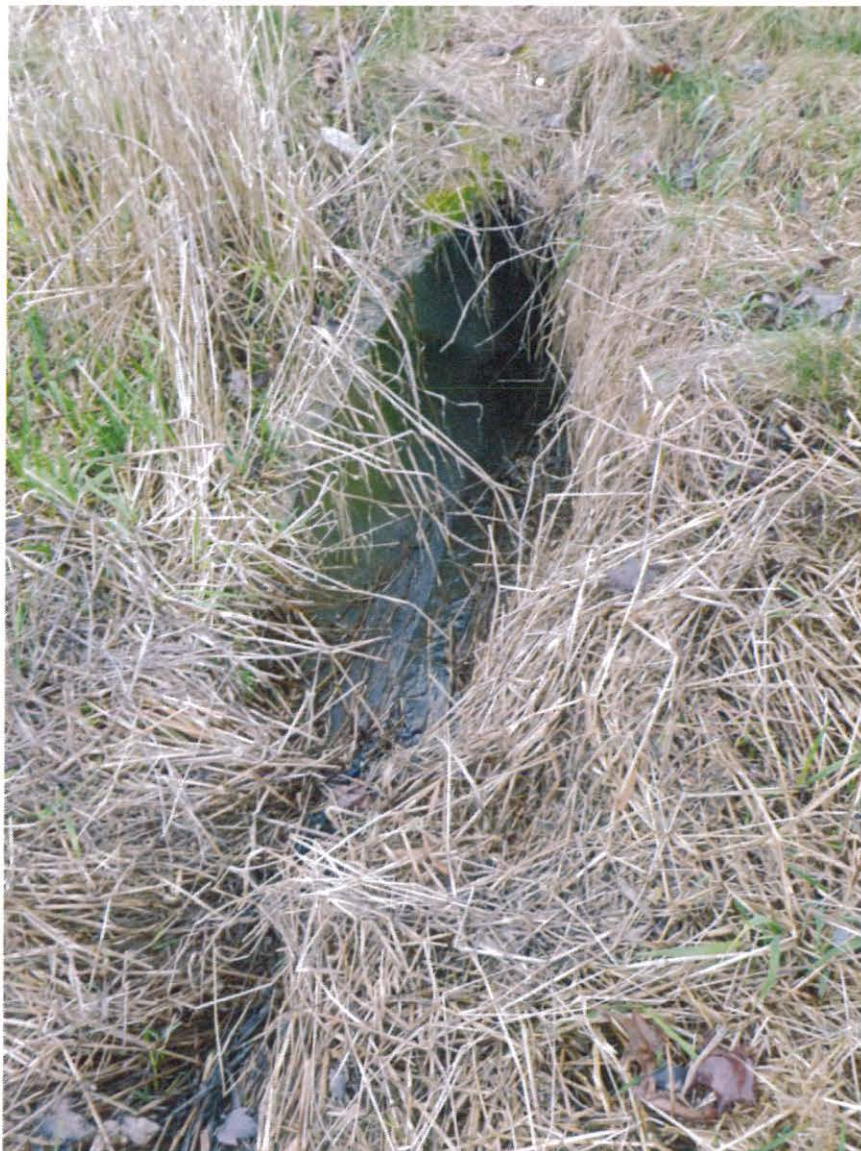
Photograph #13(P1010102-taken on 2/21/13): Facing east, this view is a continuation of the ditch from the previous photograph where it enters a culvert at the intersection of Bender Road and E. Badger Road. On February 21, 2013 there was water flowing at this point of the ditch, seen here. On February 12, 2013 water was not flowing at this point of the ditch.

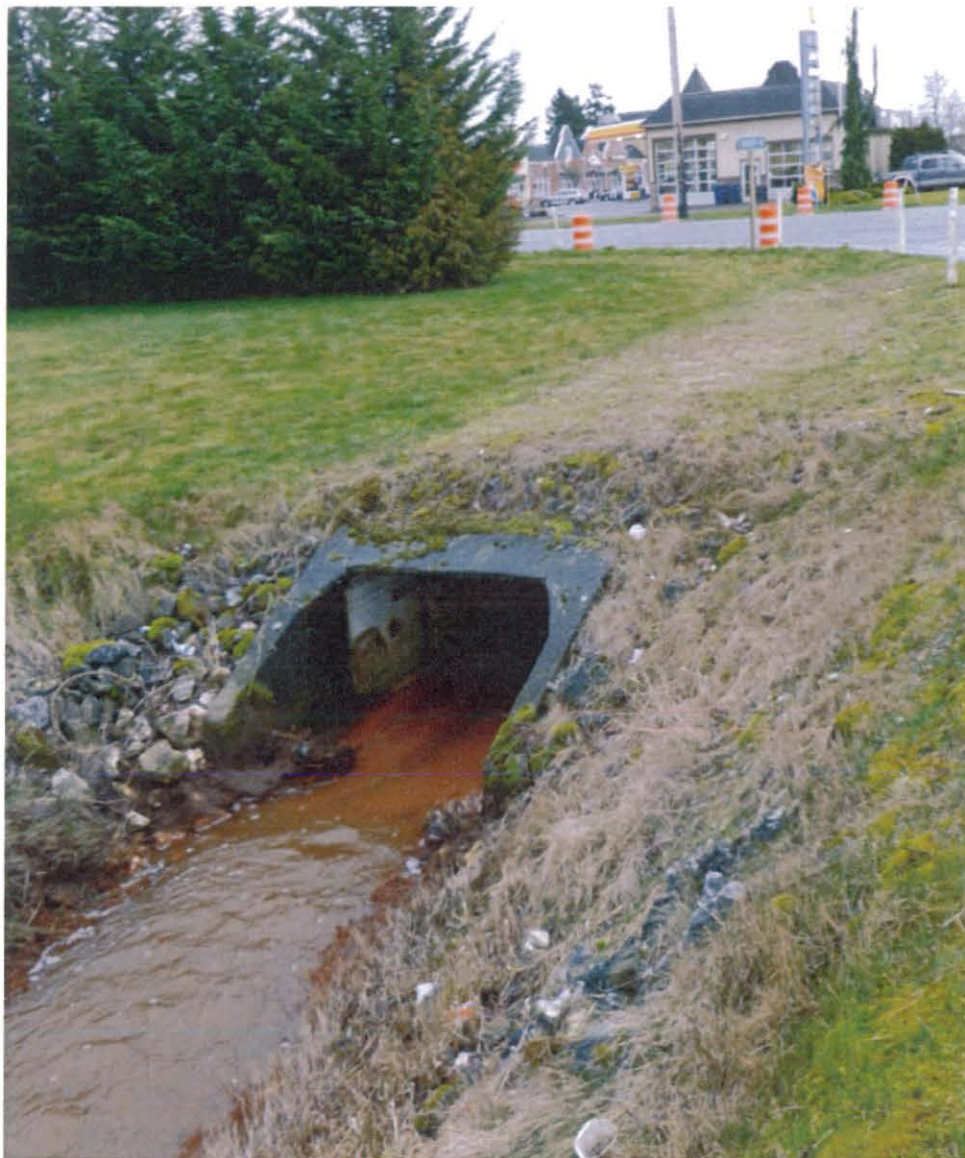
Photograph #14(P1010105-taken on 2/21/13): Looking south, this is a view of an open water conveyance that runs south along the east side of Bender Road. The ditch adjacent to the facility that runs along E. Badger Road flows toward this culvert in a perpendicular direction. In this image, flow enters a culvert north of the intersection of E. Badger Road and Bender Road. E. Badger Road appears in the background.

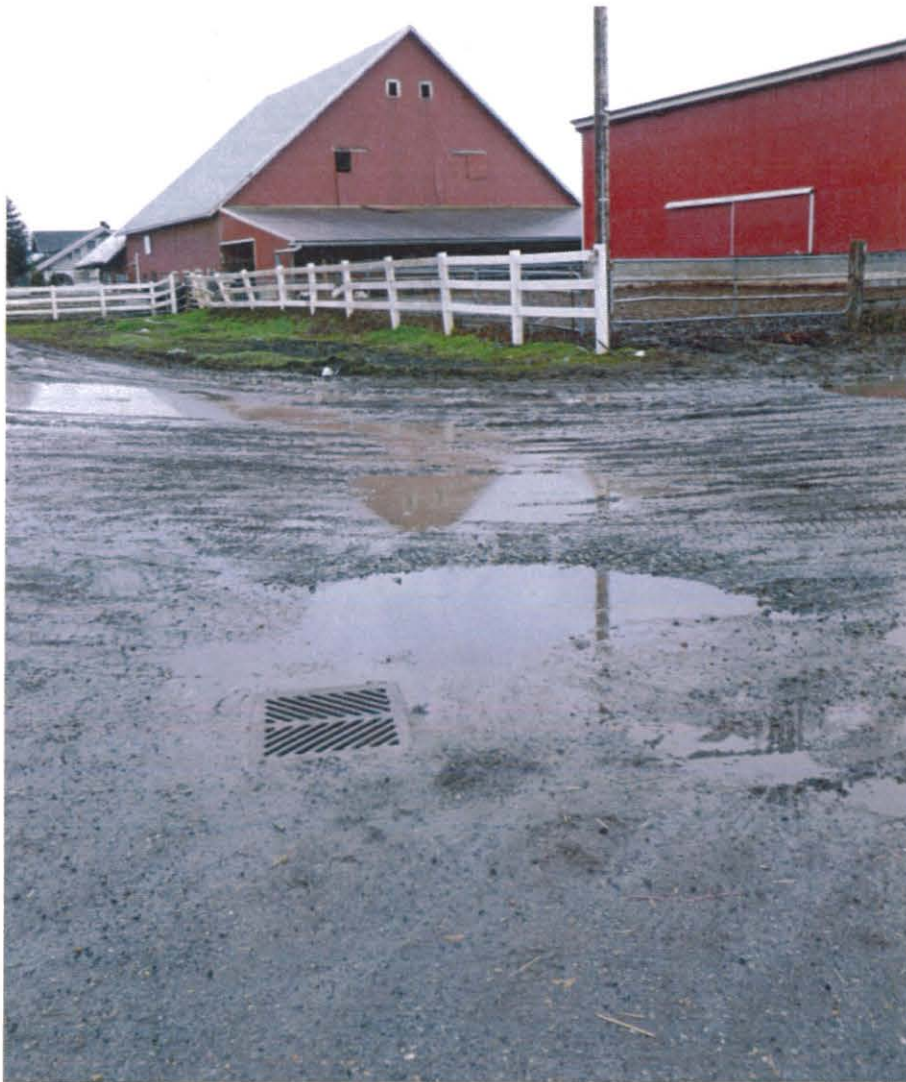
The second drain was located in between the dry cow confinement area and the ditch, on what appeared to be public roadway. Mr. Bajema stated that he did not install this drain and was put in by the city or county for runoff from the public road. On February 12 and 21, 2013 we observed water flowing into this drain. See attachment A photograph 15 for a view of this drain.

Photograph #15(P1010064-taken on 2/12/13): Looking northwest, this is a view of the dry cow confinement area and a drain. Mr. Bajema stated that this drain was installed by the city or county and routes water to the ditch.

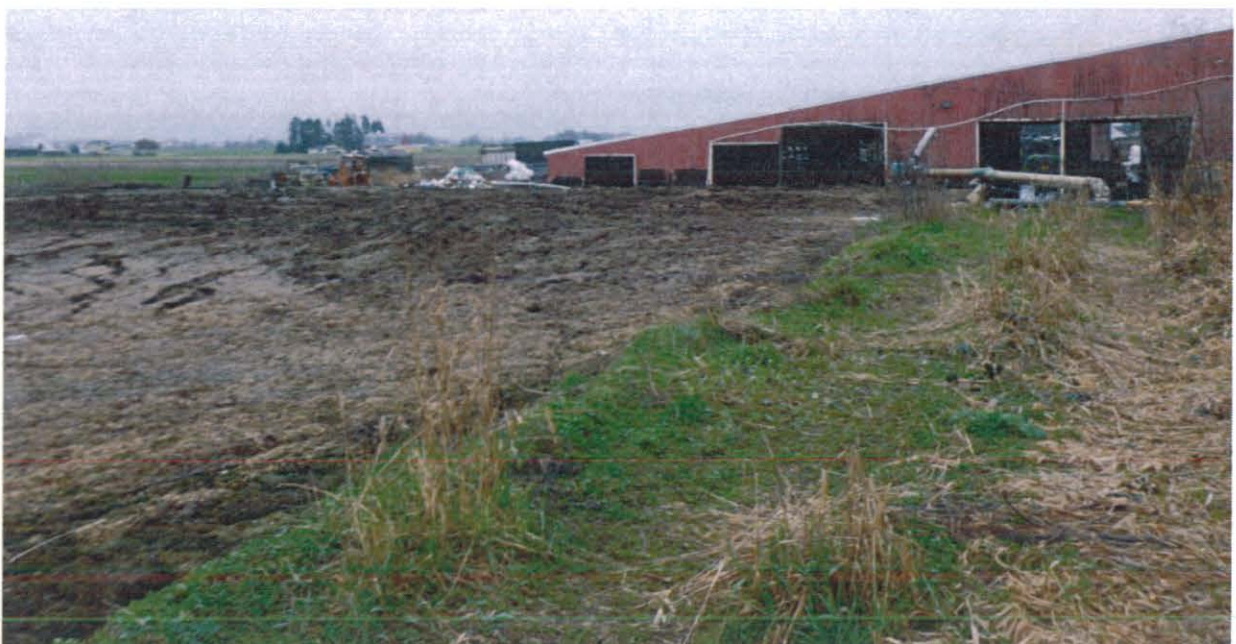
Photograph #16(P1010076-taken on 2/21/13): Looking northeast this is a partial view of the lagoon used at the facility.

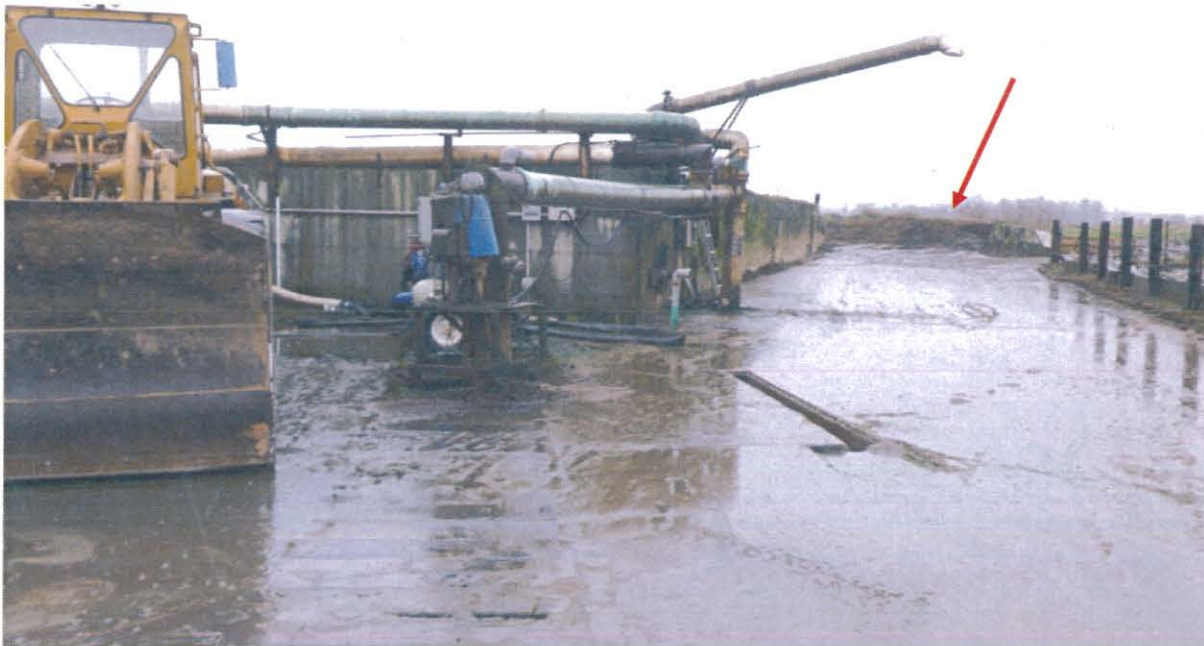
Photograph #17(P1010073-taken on 2/21/13): Looking north this is a view of the elevated lagoon on the left and one solid storage area on the right. Mr. Bajema indicated that solids will be scraped off the top of the lagoon and stored in the area, indicated by the red arrow.

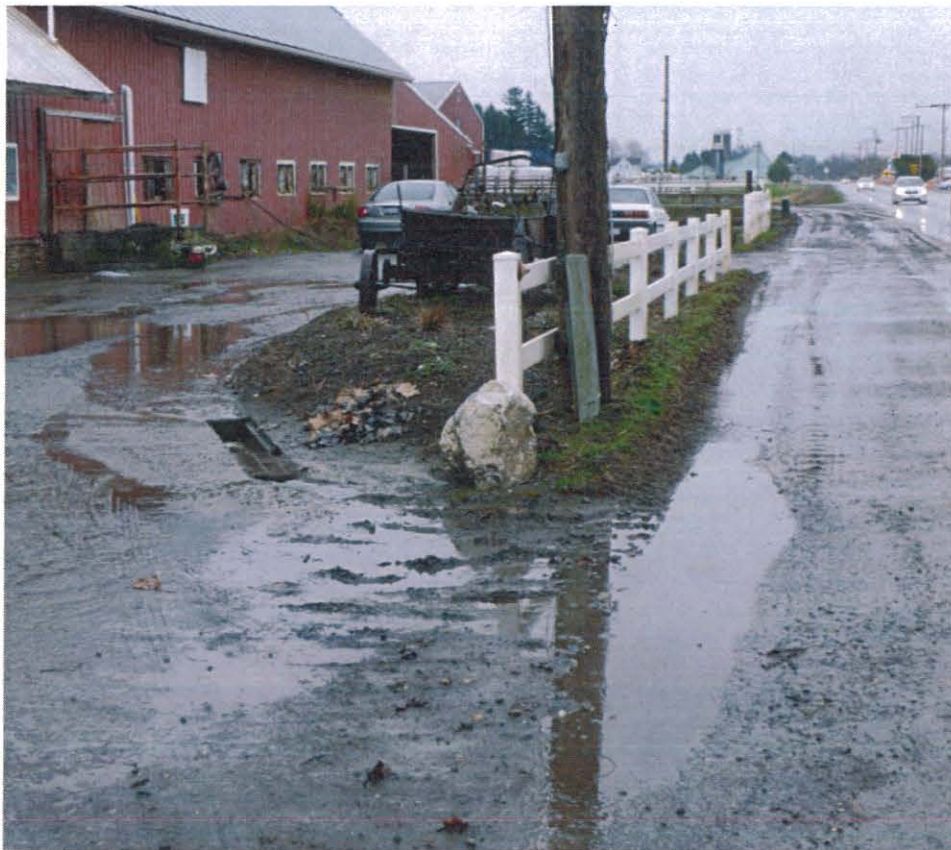
One drain was located on the property just south of the milk house. On February 12 and 21, 2013 we observed water flowing into this drain. According to Mr. Bajema this drain is used to drain roof runoff primarily from the milk house. Occasionally Mr. Bajema will pump water from a well to help remove sediment

Photograph #18(P1010062-taken on 2/12/13): Looking east this is a view of a drain located on the south side of the milk house. According to Mr. Bajema, this drain routes water to the ditch and is used to drain roof runoff primarily from the milk house. A small pump, which appears in the background, is used to periodically purge a water well in this location outside the milk house. This purged well water also drains to this area. The EPA inspectors observed the pump in operation on February 12, 2013.

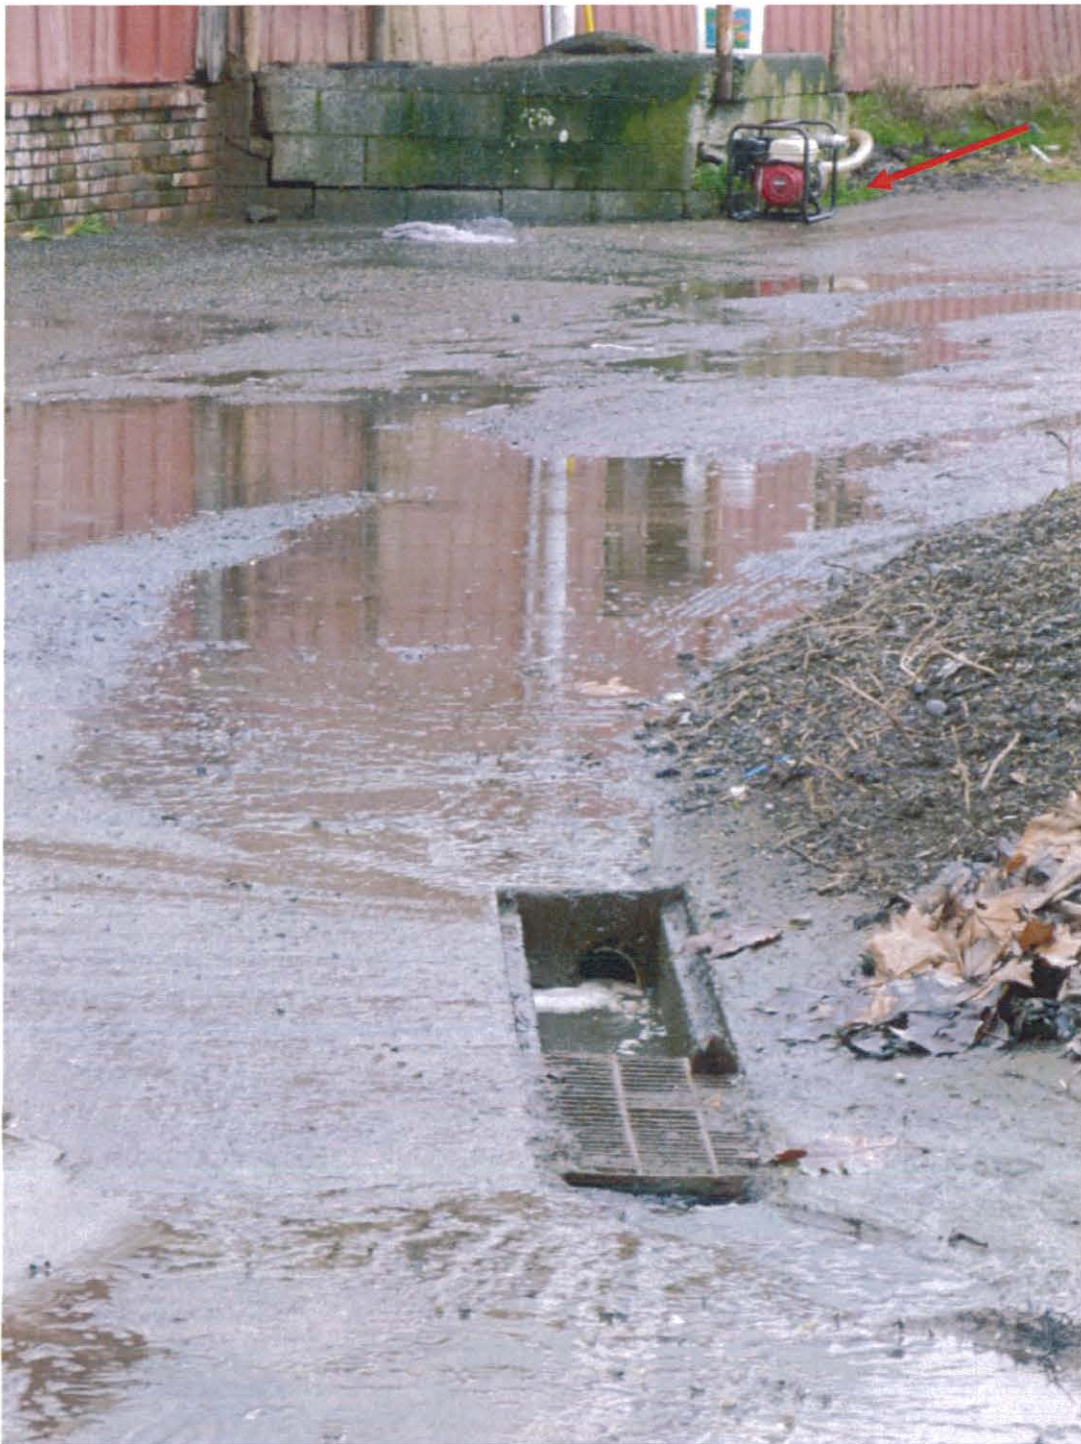
Photograph #19(P1010061-taken on 2/12/13): A close up view of the drain seen in the previous picture. The red arrow points to the pump used for well water. The well is located just behind the pump seen here.
